Limited Condition Survey Report

1607 22nd Street
Ybor City
Tampa, Florida

Issue Date:
October 7, 2008

BRSR Project No. 08-218

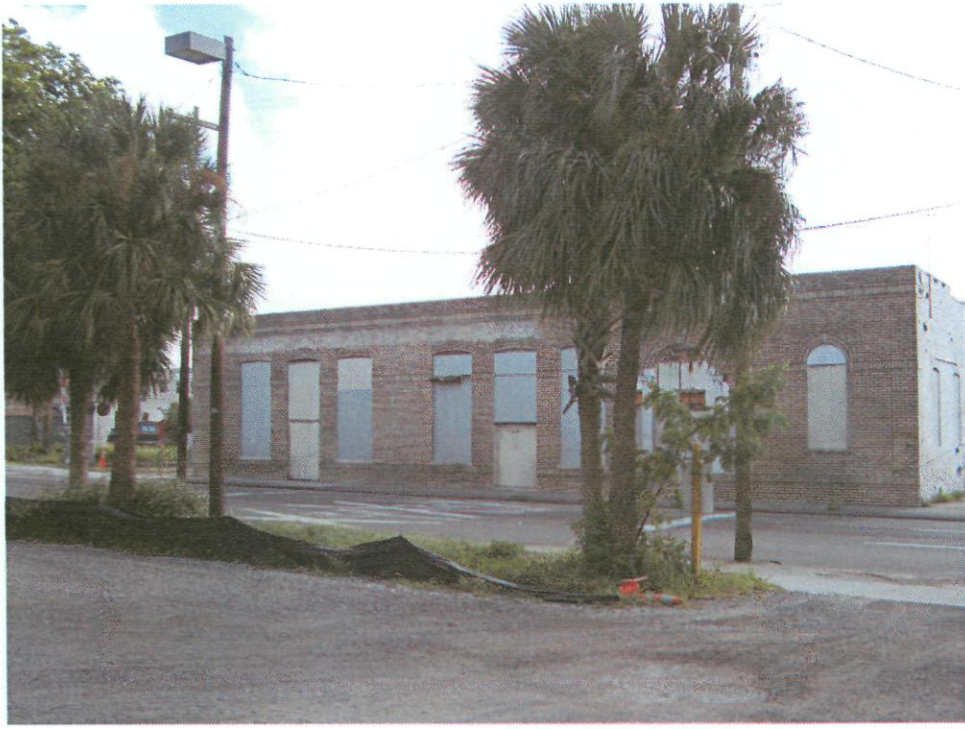
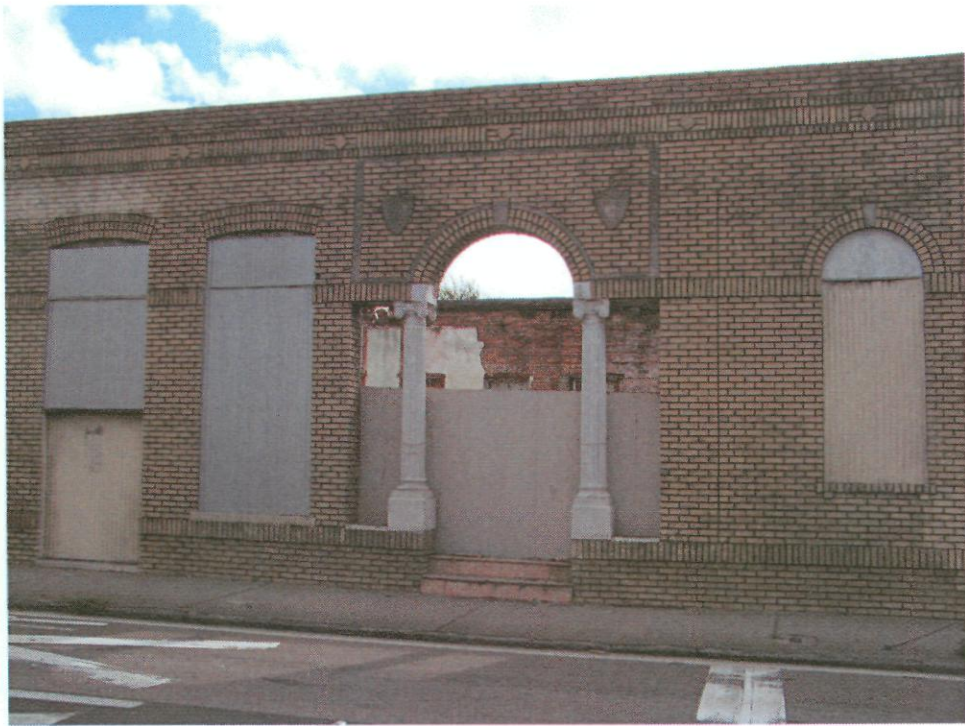
1. **West Elevation (front face of the building)**
 - a. The west elevation is shown in *Figures A-1* and *A-2*.
 - b. The top portion of the wall at the north end of the elevation visibly bows outward.

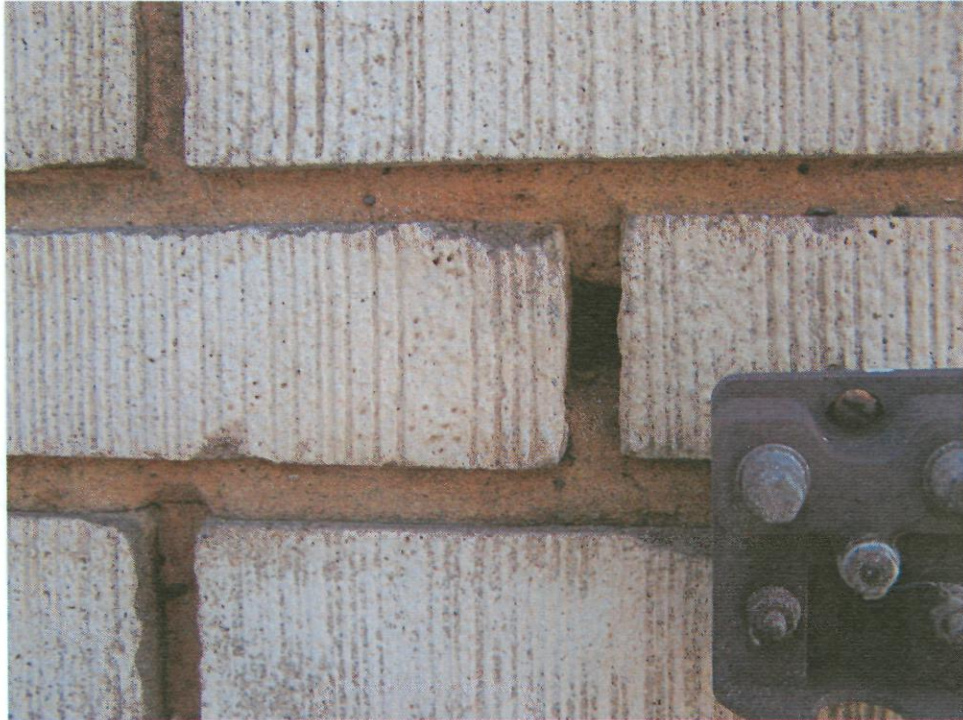
Figure A- 3

- c. Mortar deterioration was observed throughout the elevation. Refer to *Figure A-3*.
 - d. Vertical cracking (widths up to approximately $\frac{1}{2}$ ") was observed at the top section of the column. Refer to *Figure A-4*.

4. Cracking and/or spalling of the mortar joints or bricks requires repointing of the joints and should be conducted with the joints being properly tooled. Most of the mortar joints throughout the existing walls appeared deteriorated. All of the mortar joints should be repointed.

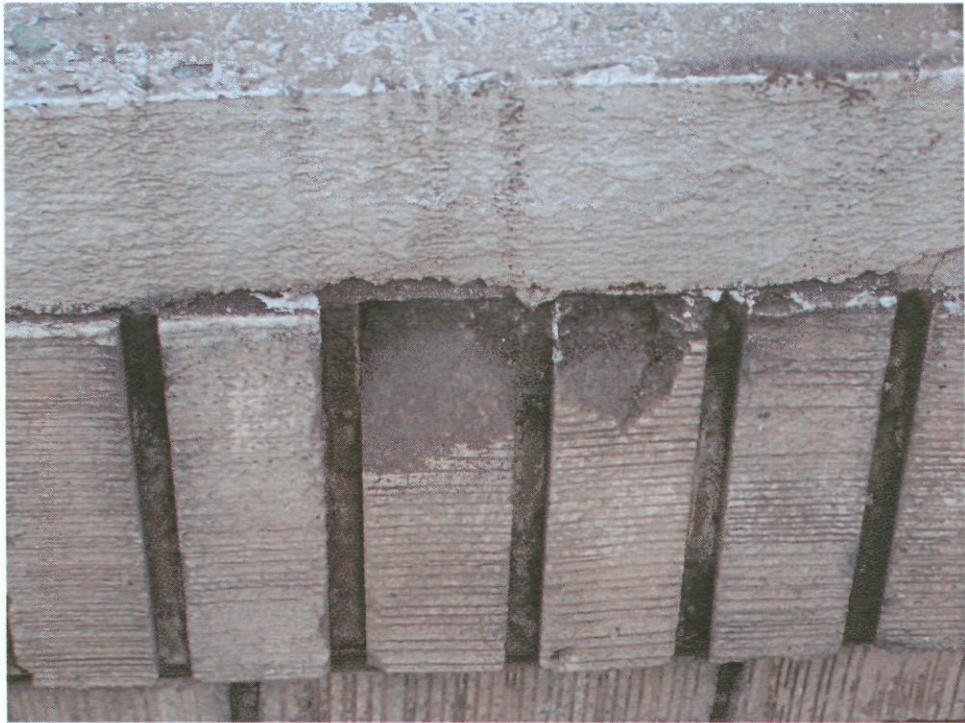
Figure A- 5

- e. Localized brick damage was observed in the wall. Refer to *Figure A-5*.
 - f. A brick was observed to be missing in the wall adjacent to the upper left corner of the window opening. Refer to *Figure A-6*.

6. The impact damage to the brick veneer can be repaired by removing and replacing the damaged bricks.
7. The cracking/spalling observed within concrete elements (window sills, columns, etc.) was found to be consistent with insufficient concrete cover over the reinforcing steel allowing the steel to corrode due to moisture exposure. Steel expands when it corrodes, resulting in additional cracking and spalling of the surrounding concrete. BillerReinhart recommends removal of the delaminating concrete, any exposed reinforcing steel be removed and replaced, concrete be re-poured insuring proper cover over the new reinforcement. Deteriorated concrete elements could also be removed and replaced.

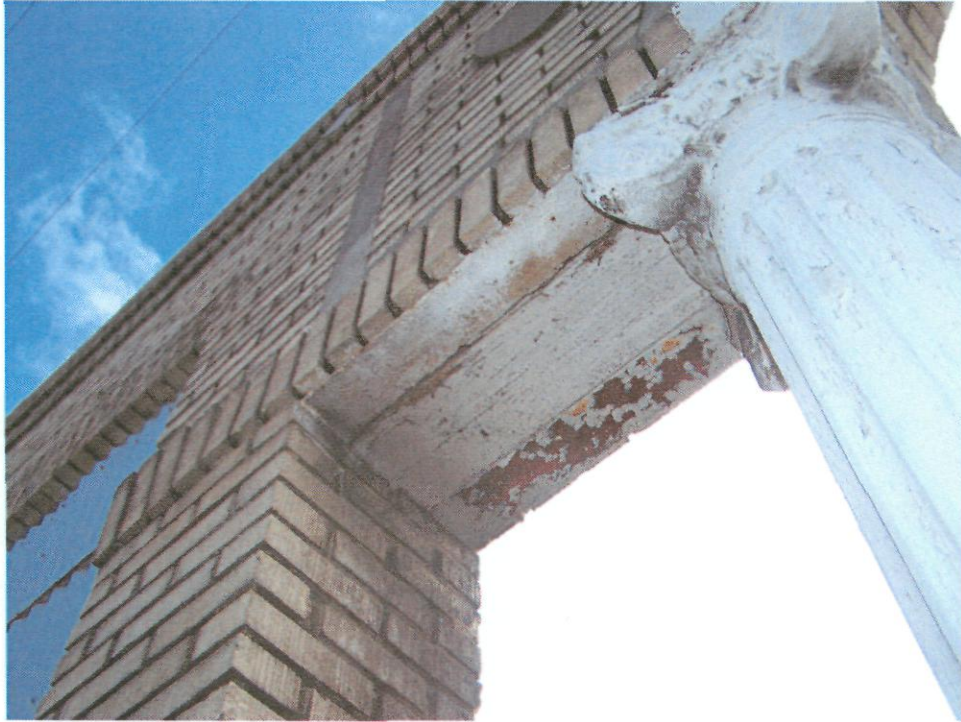
Figure A- 7

- g. Corrosion was observed in the lintel plate. Refer to *Figure A-7*.
 - h. Cracking was observed in the window sills throughout the elevation. Refer to *Figure A-8*.

5. The brick lintel angles evidencing surface corrosion should be properly cleaned by wire brushing and finished with a protective coating. Lintel angles evidencing significant corrosion should be removed and replaced.

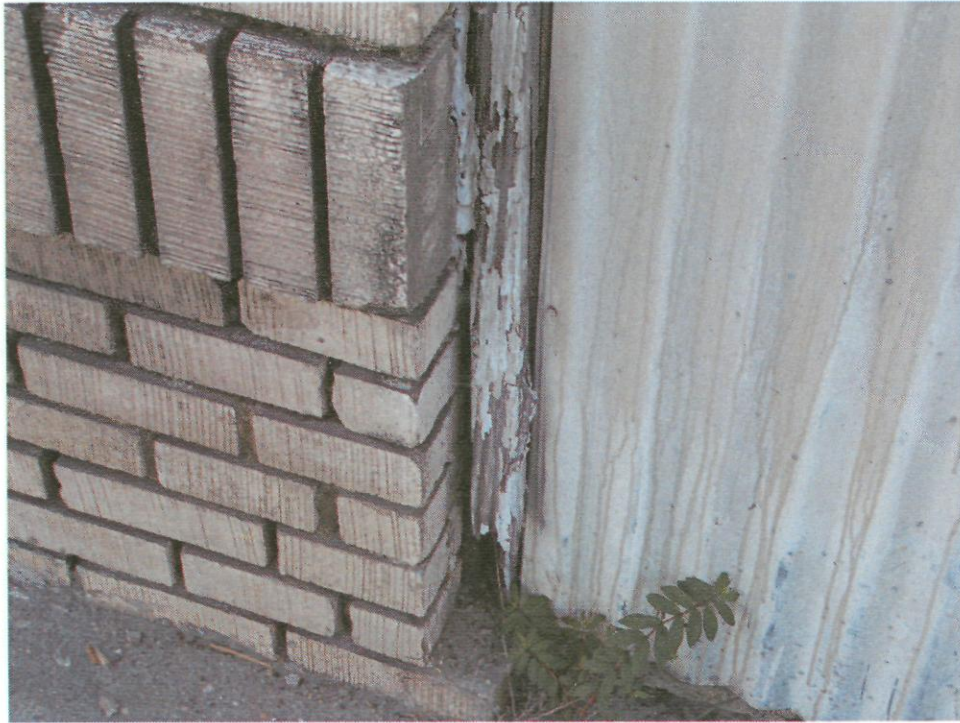
Figure A- 9

- i. Deterioration was observed in the wood door frame. Refer to *Figure A-9*.
2. **North Elevation**
 - a. The north elevation is shown in *Figure A-10*.

10. Deteriorated wood door frames and window frames and lintels should be replaced.
11. The existing metal scuppers and drainage pipes should be replaced.

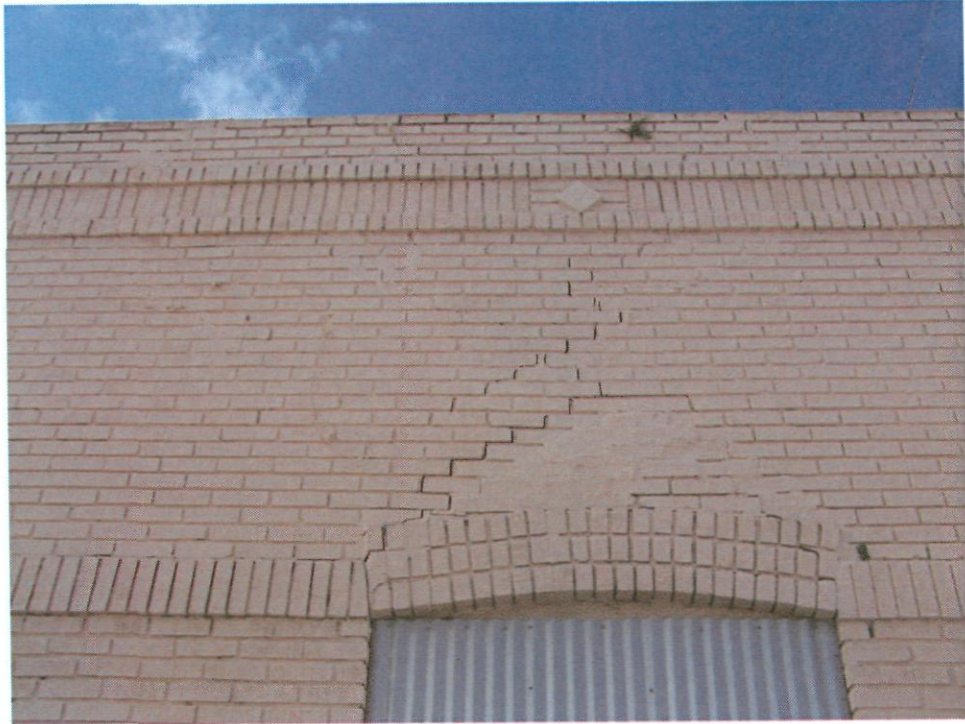
Figure A- 11

- b. Diagonal "stair-step" cracking (widths up to approximately $\frac{1}{2}$ ") in the wall was observed in the mortar above the west window opening. Refer to *Figure A-11*.

8. The remaining floor slab should be removed and replaced.
9. The isolated "stair-step" wall cracking observed should be repaired by properly repointing the affected mortar joints.

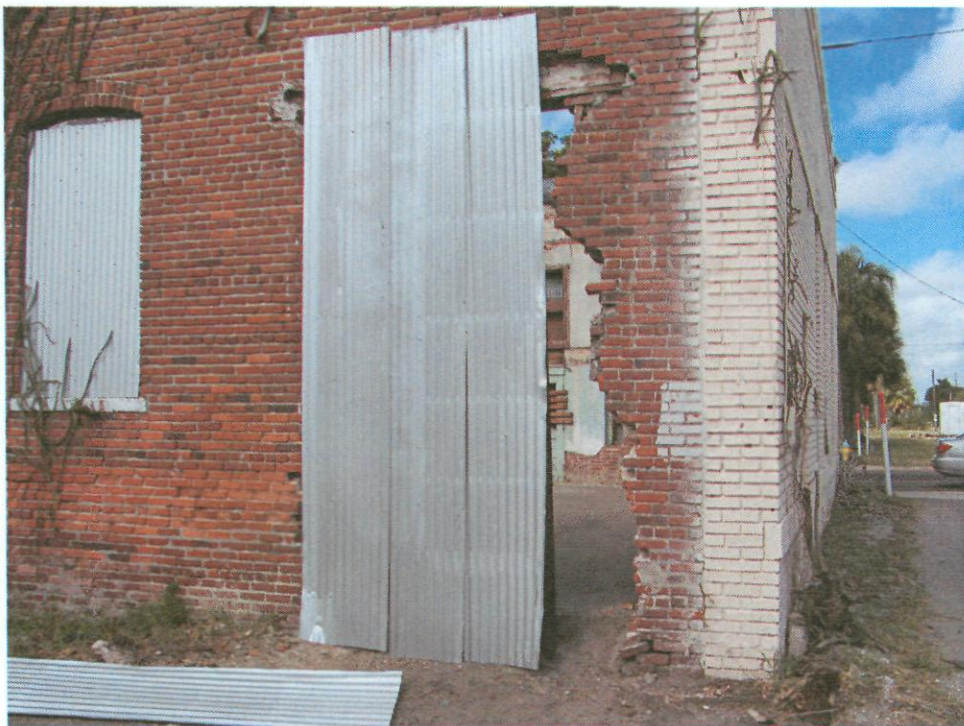
Figure A- 14

- a. The east elevation is shown in *Figure A-13*.
- b. The top portion of the wall at the north end of the elevation visibly bows outward.
- c. Sections of the brick wall were observed to be missing around the perimeter of the door opening. Refer to *Figure A-14*.

12. The deteriorated cementitious wall finish on the interior of the existing walls should be removed.
13. Missing and displaced masonry brick units should be replaced. This will require rebuilding localized wall sections.

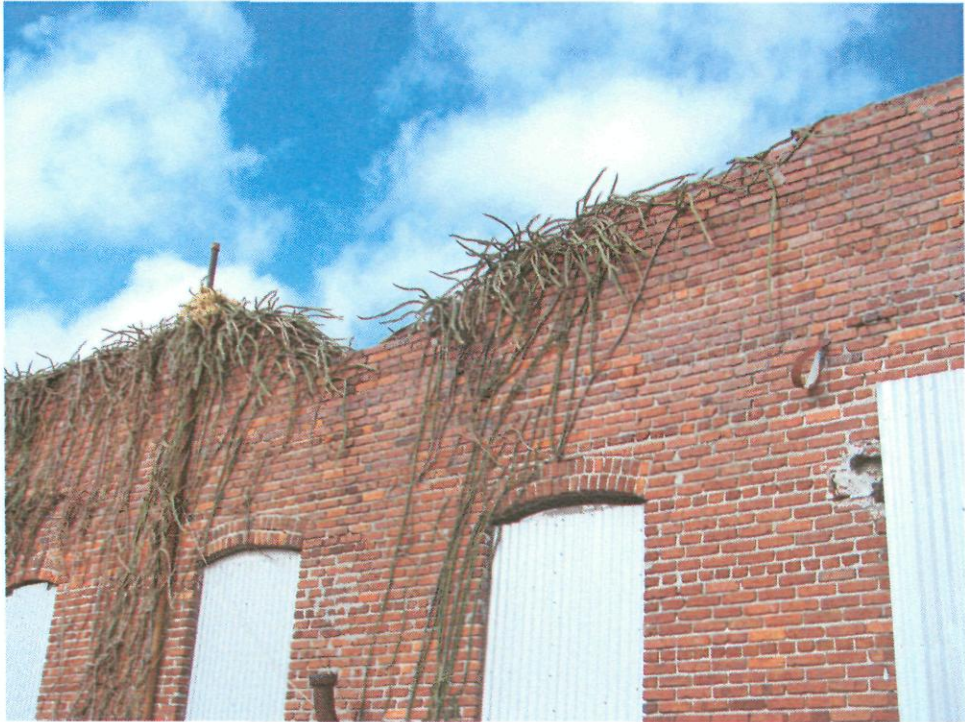
Figure A- 15

- d. A section of the brick wall was observed to be missing above the first and second window openings from the north end of the elevation. Refer to *Figure A-15*.

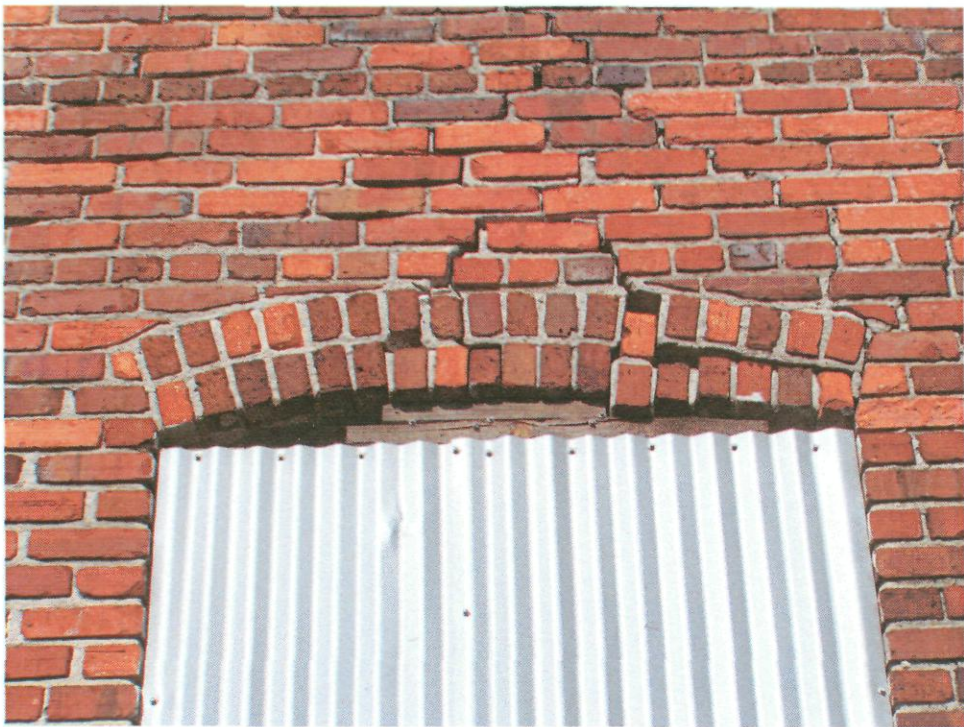
Figure A- 16

- i. Bricks were observed to be dislodged over the second and fifth windows from the south end of the elevation. Refer to *Figure A-16*.
- j. The scupper and drainage system were observed to be corroded. Refer to *Figure A-17*.

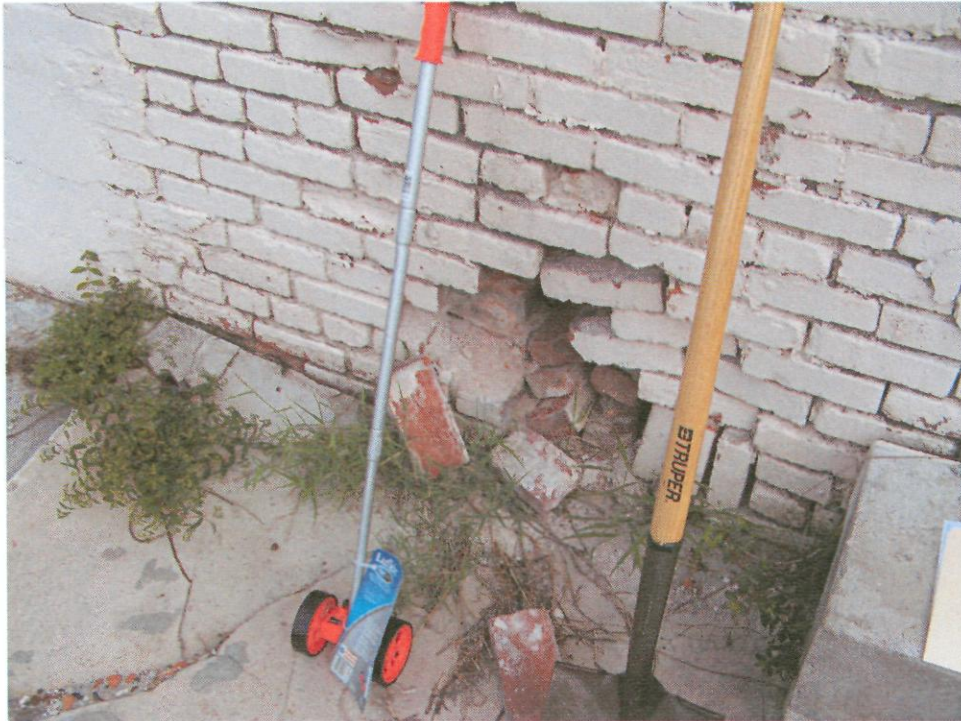
Figure A- 19

- f. Bricks were observed to be dislodged at the bottom left corner of the door opening. Refer to *Figure A-19*.
- g. Vegetation was observed to be growing in the wall.
- h. Cracking in the wall was observed in the brick above the first and second window openings from the west end of the elevation. Refer to *Figure A-20*.
- i. Bricks were observed to be dislodged above the first and second window openings from the west end of the elevation. Refer to *Figure A-20*.

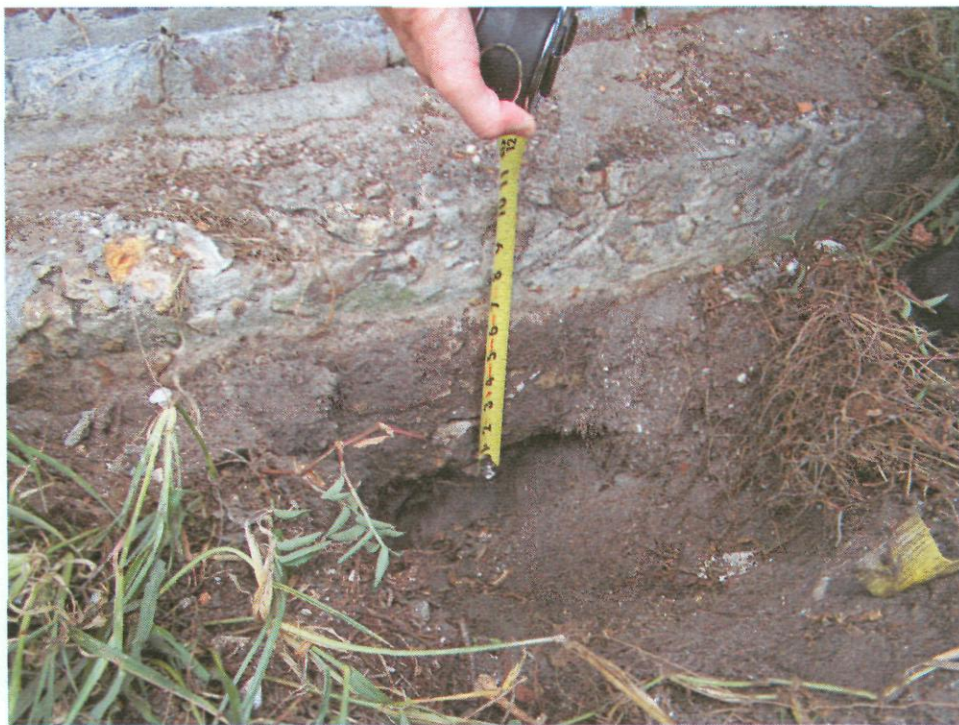
Figure A- 22

- 1. Test Pit 1 was performed at the south end of the east elevation. The foundation appeared to be a rectangular-shaped continuous strip wall footing, approximately 11 inches thick, extending approximately 7 ½ inches from the exterior wall face, and extending approximately 5 inches from the interior wall. The total width of the footing is approximately 30 inches. The top of the foundation was approximately at grade. Refer to *Figure A-21*.
- 2. Test Pit 2 was performed at the north end of the east elevation. The footing configuration was similar to that measured at Test Pit 1. Refer to *Figure A-22*.

The existing foundations were found to be embedded 11 inches below grade. According to the *Florida Building Code 2004* (FBC 2004) Section 1805.3, "The minimum depth of footings below the undisturbed ground surface shall be 12 inches."

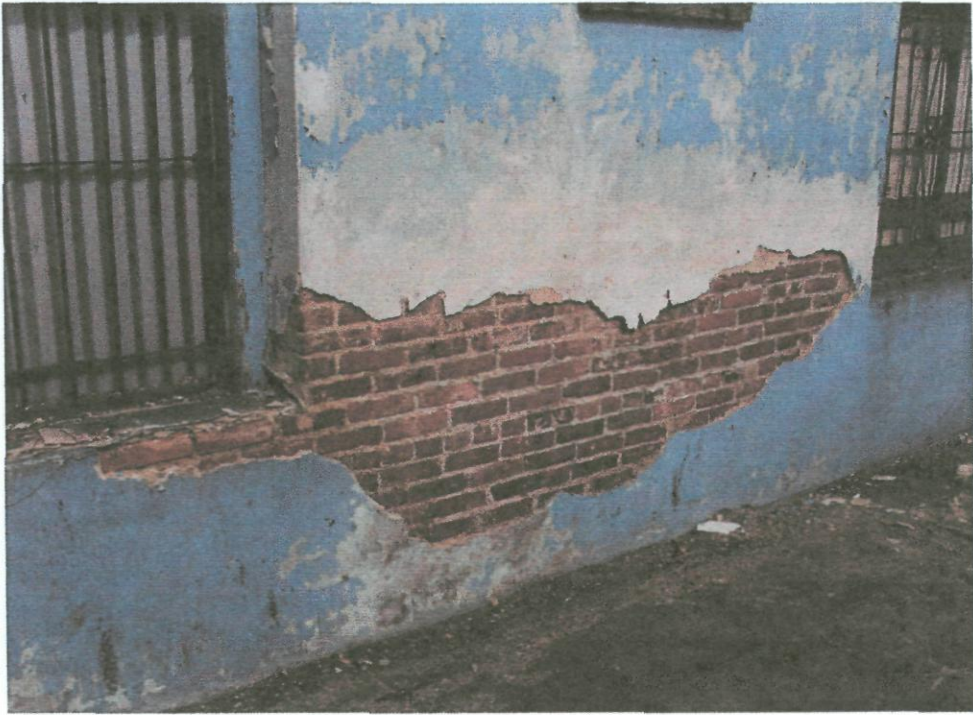
Figure B- 5

- f. Delamination and deterioration of the interior cementitious finish were observed throughout the elevation. Refer to *Figure B-5*.
- g. Localized dislodged brick sections were observed throughout the elevation. Refer to *Figure B-6*.
- h. Deterioration of the timber door and window lintels was observed throughout the elevation. Refer to *Figure B-7*.

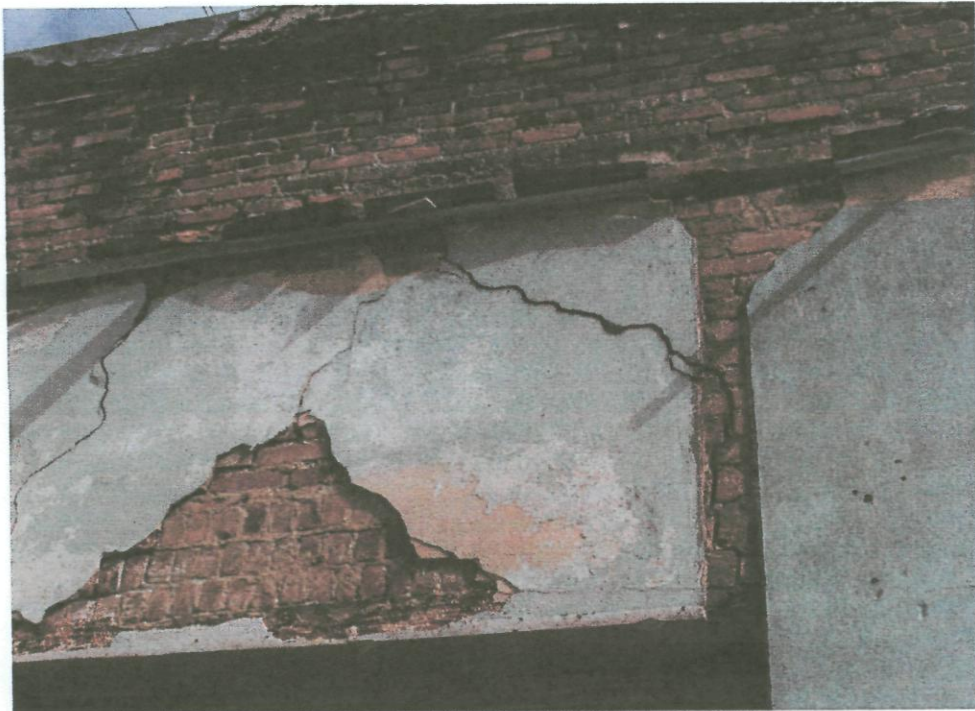
Figure B- 10

- a. The north elevation is shown in *Figure B-8*.
- b. Mortar deterioration was observed throughout the elevation.
- c. Localized brick damage was observed in the wall.
- d. Deterioration of the timber windows and doors was observed throughout the elevation.
- e. Delamination and deterioration of the interior cementitious finish were observed throughout the elevation.
- f. Deterioration of the timber door and window lintels was observed throughout the elevation.
- g. A section of the brick was observed to be dislodged at the base of the east window opening. Refer to *Figure B-9*.
- h. "Stair-step" cracking (widths up to approximately $\frac{1}{2}$ ") in the wall was observed above the west window opening. Refer to *Figure B-10*.

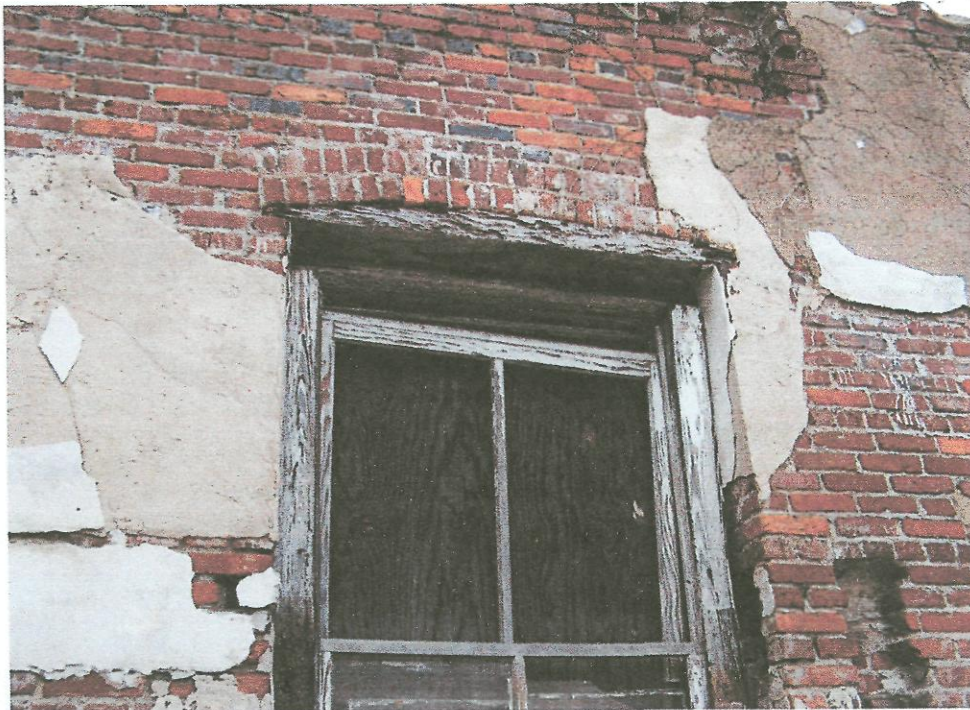
Figure B- 12

- h. Deterioration of the timber door and window lintels was observed throughout the elevation. Refer to *Figure B-12*.
- i. A localized course of bricks were observed to be dislodged/missing under the first, second and third window openings from the south end of the elevation. Refer to *Figure B-13*.

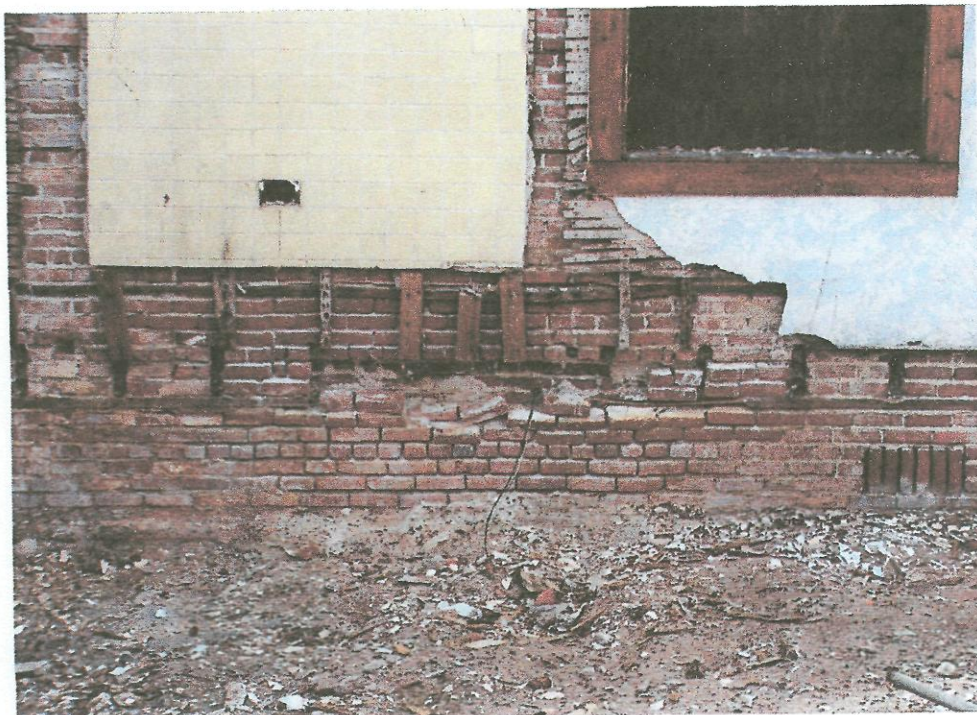
Figure B- 16

- a. The south elevation is shown in *Figure B-14*.
- b. Mortar deterioration was observed throughout the elevation.
- c. Localized brick damage was observed in the wall.
- d. Deterioration of the timber windows and doors was observed throughout the elevation.
- e. Deterioration of the timber door and window lintels was observed throughout the elevation.
- f. Vertical "stair-step" cracking (widths up to approximately $\frac{1}{2}$ ") in the wall was observed above the second window opening from the west end of the elevation. Refer to *Figure B-15*.
- g. Localized bricks were observed to be dislodged/missing along the base of the wall. Refer to *Figure B-16*.
