Limited Condition Survey Report

1607 22nd Street
Ybor City
Tampa, Florida

Issue Date:
October 7, 2008

BRSR Project No. 08-218

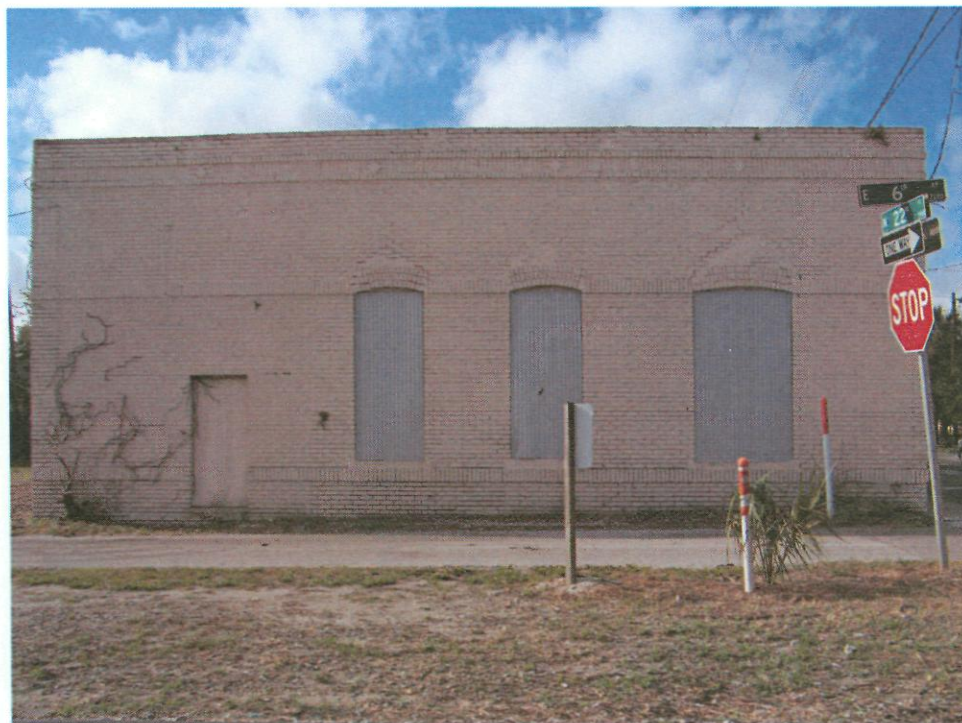
Figure A- 10

- i. Deterioration was observed in the wood door frame. Refer to *Figure A-9*.
2. **North Elevation**
 - a. The north elevation is shown in *Figure A-10*.

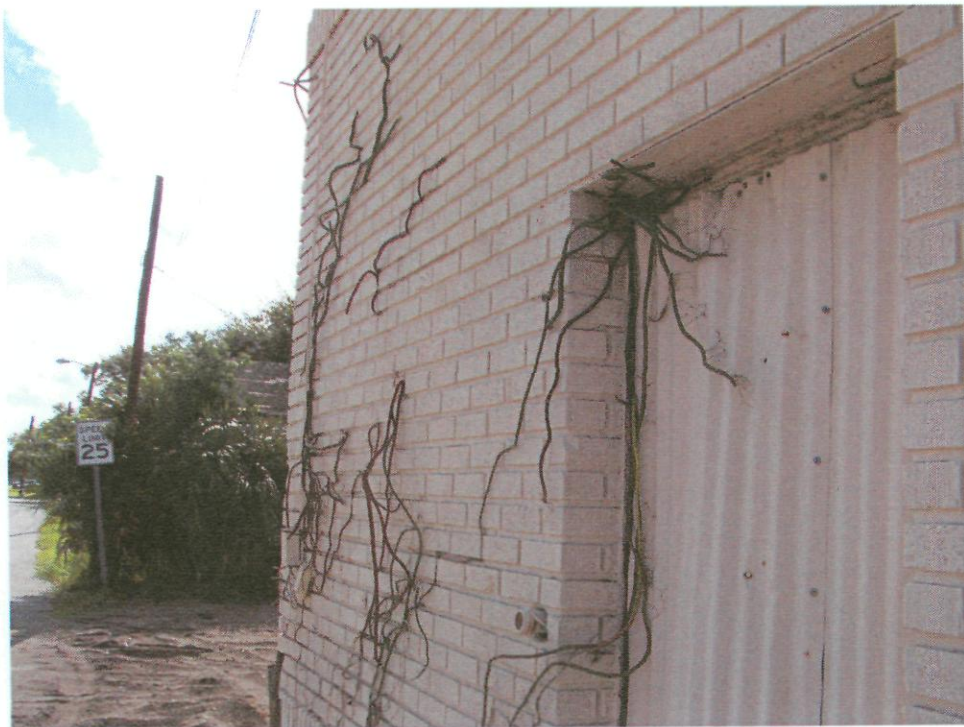
Figure A- 12

- c. Mortar deterioration was observed throughout the elevation.
- d. Localized brick damage was observed in the wall.
- e. Cracking was observed in the window sills throughout the elevation.
- f. Vegetation was observed to be growing in the wall. Refer to *Figure A-12*.
- g. Diagonal "stair-step" cracking (widths up to approximately ½") in the wall was observed in the mortar above the center window opening.
- h. Diagonal "stair-step" cracking (widths up to approximately ½") in the wall was observed in the mortar above the east window opening.

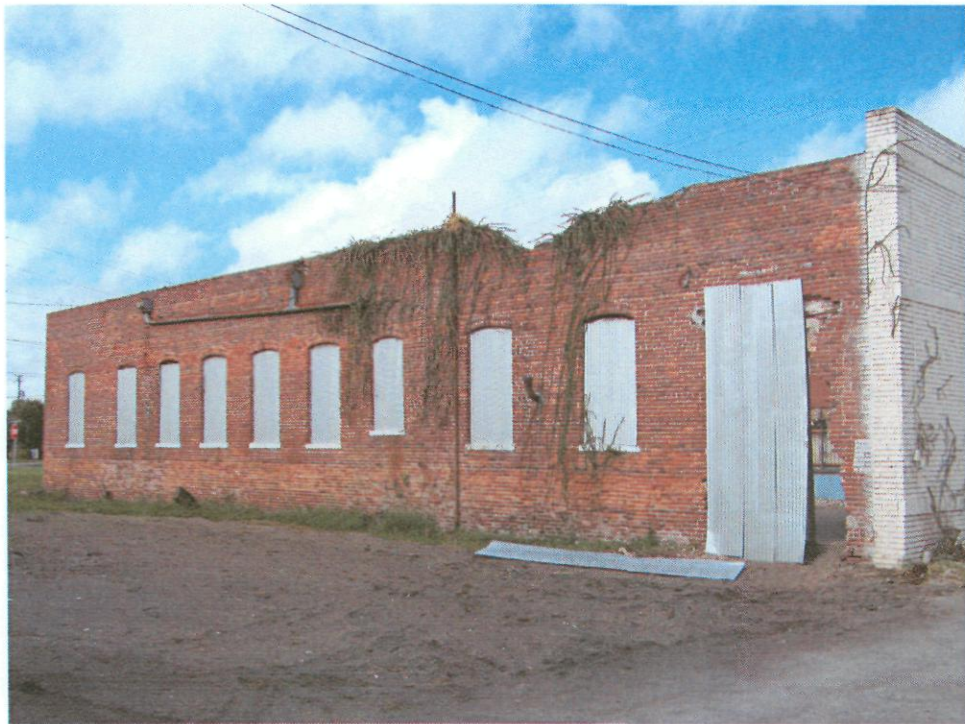
Figure A- 13

- a. The east elevation is shown in *Figure A-13*.
- b. The top portion of the wall at the north end of the elevation visibly bows outward.
- c. Sections of the brick wall were observed to be missing around the perimeter of the door opening. Refer to *Figure A-14*.

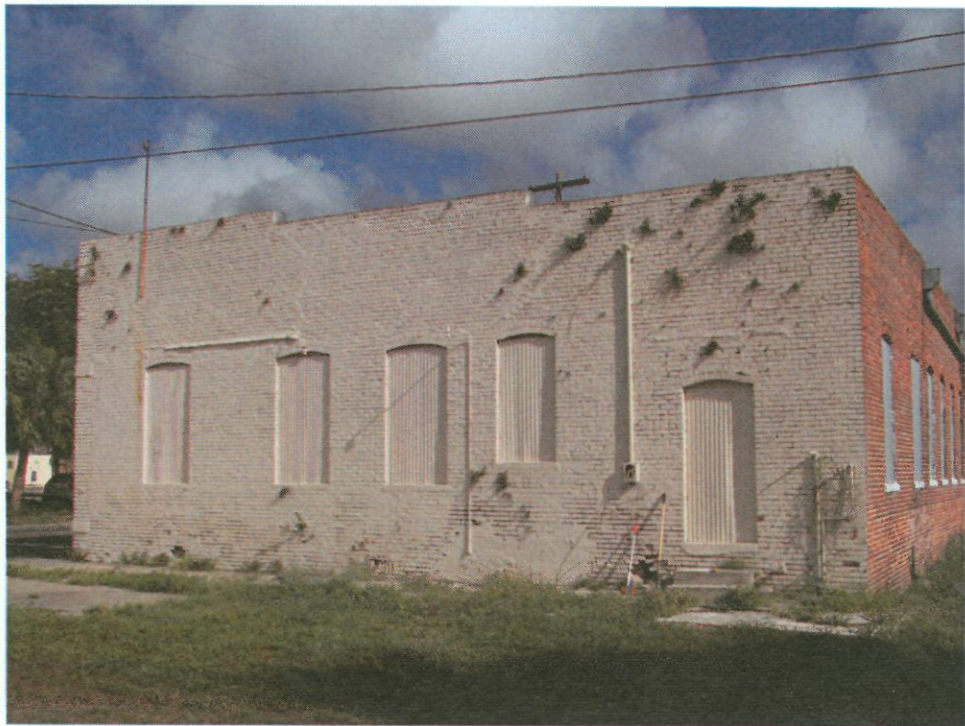
Figure A- 18

- a. The south elevation is shown in *Figure A-18*.
- b. The top portion of the wall at the center of the elevation visibly bows inward.
- c. Mortar deterioration was observed throughout the elevation.
- d. Localized brick damage was observed in the wall.
- e. Cracking was observed in the window sills throughout the elevation.

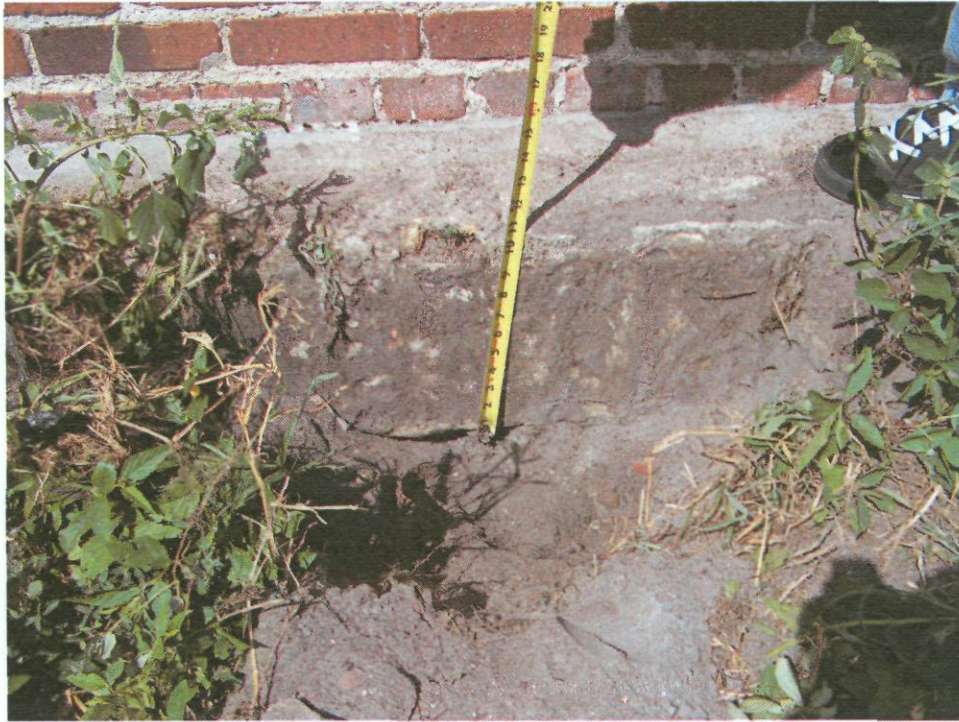
Figure A- 21

- 1. Test Pit 1 was performed at the south end of the east elevation. The foundation appeared to be a rectangular-shaped continuous strip wall footing, approximately 11 inches thick, extending approximately 7 ½ inches from the exterior wall face, and extending approximately 5 inches from the interior wall. The total width of the footing is approximately 30 inches. The top of the foundation was approximately at grade. Refer to *Figure A-21*.
- 2. Test Pit 2 was performed at the north end of the east elevation. The footing configuration was similar to that measured at Test Pit 1. Refer to *Figure A-22*.
